CASE STUDY - POST FLOOD RENOVATION - TEWKESBURY (1)

CASE STUDY - POST FLOOD RENOVATION - TEWKESBURY (2)

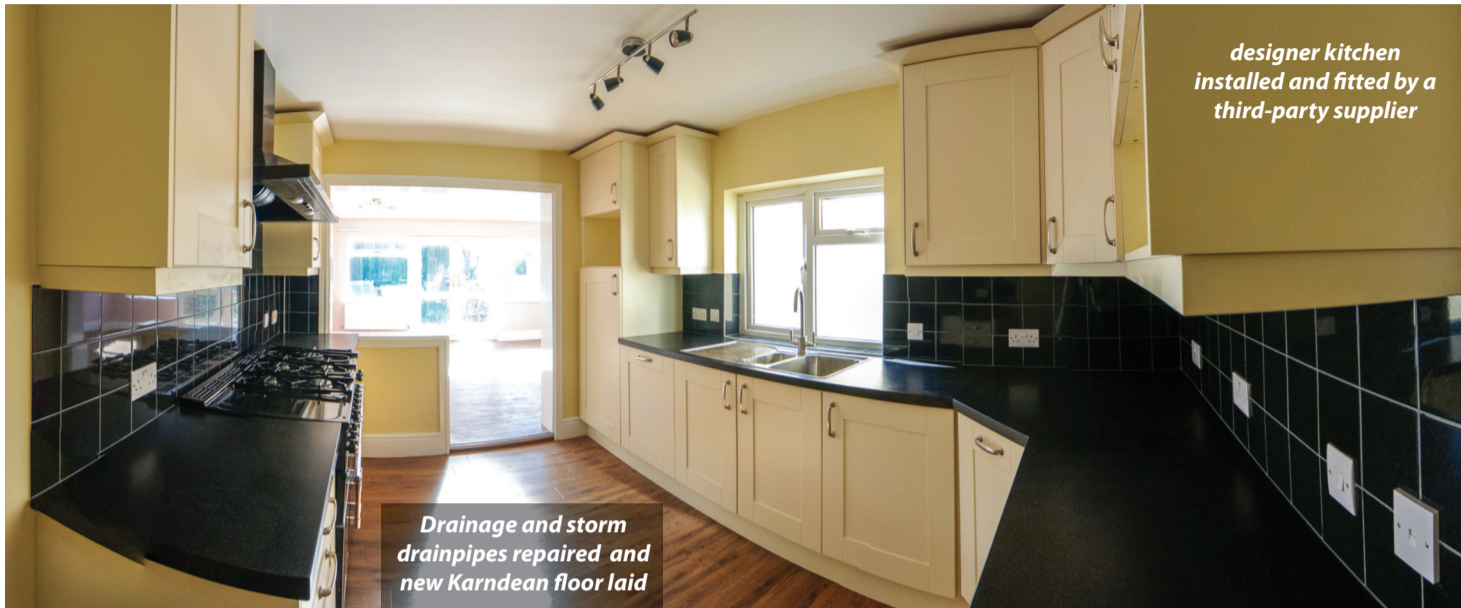
designer kitchen installed and fitted by a third-party supplier

Drainage and storm drainpipes repaired and new Karndean floor laid

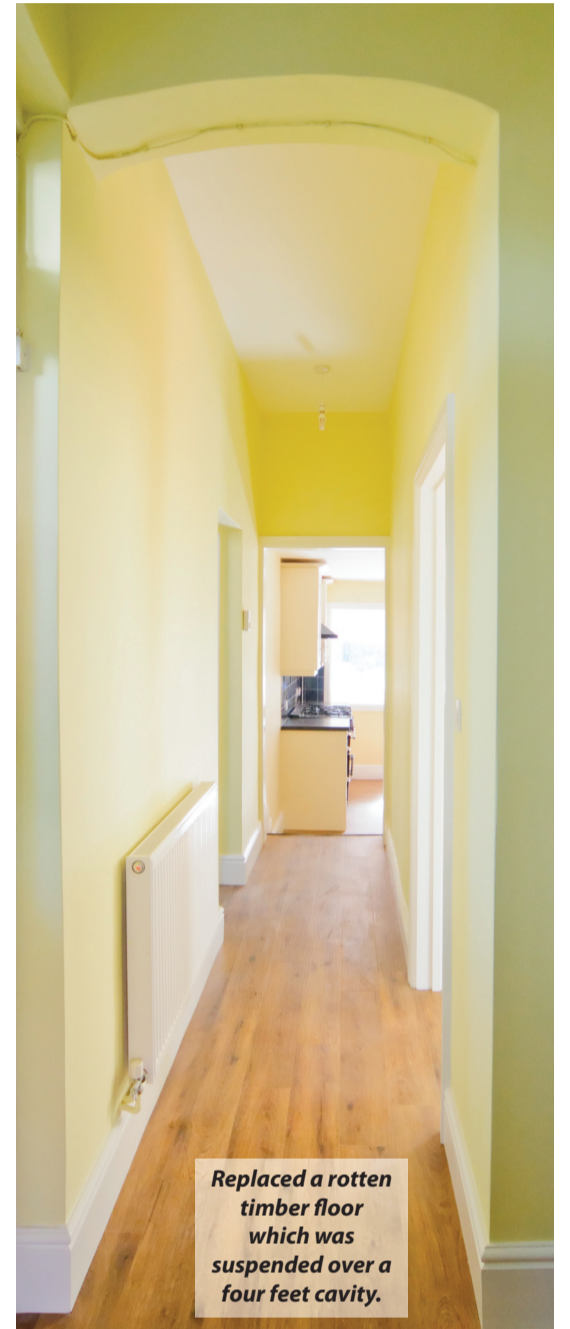
Replaced a rotten timber floor which was suspended over a four feet cavity.

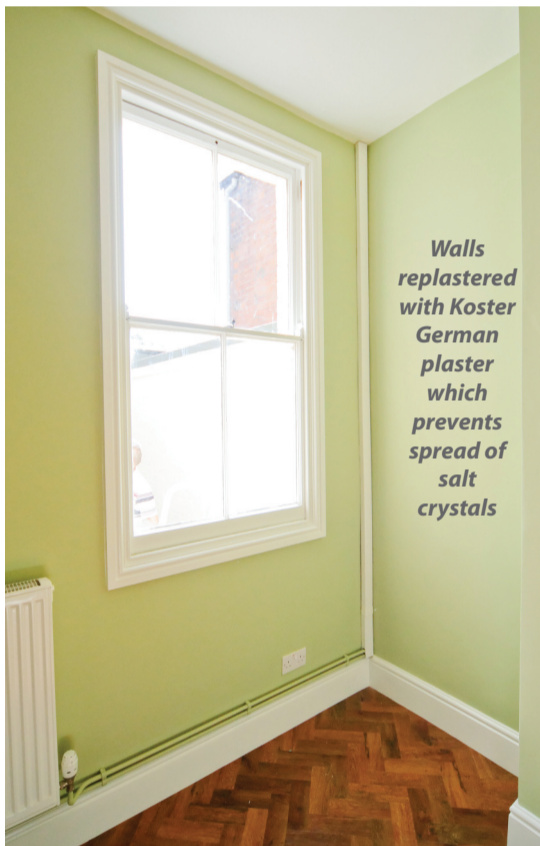
Walls replastered with Koster German plaster which prevents spread of salt crystals

- Re-install main electric leads and plumbing framework
- Replastering with high-performance Koster German plaster - a cement based product specially designed to stop the spread of salt crystals - used in swimming pools
- Re-install socket faces of electrics, fittings, architraves, skirting boards and radiators.
- Kitchen installed as a designer kitchen range (branded) from a third-party company.
- Warm floors and radon barriers installed where necessary, overlaid with Karndeal vinyl or carpet

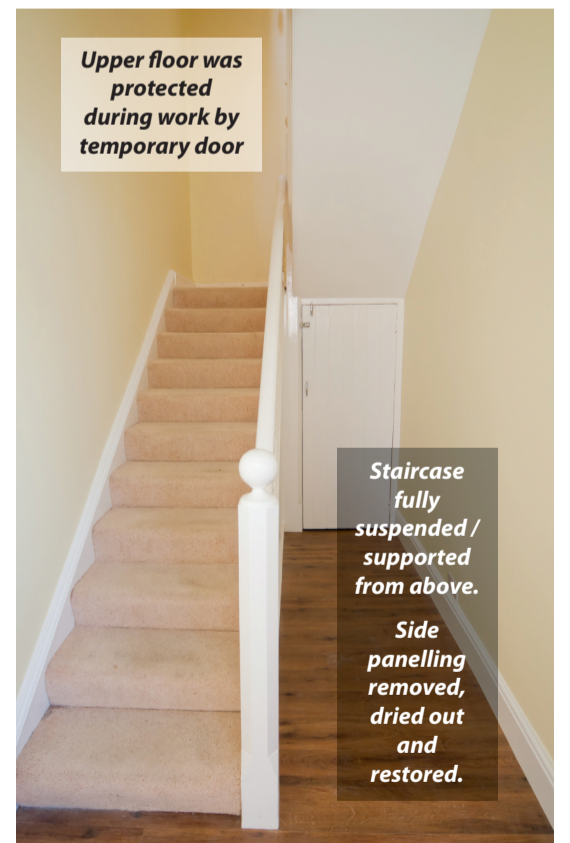
Upper floor was protected during work by temporary door

Staircase fully suspended / supported from above. Side panelling removed, dried out and restored.

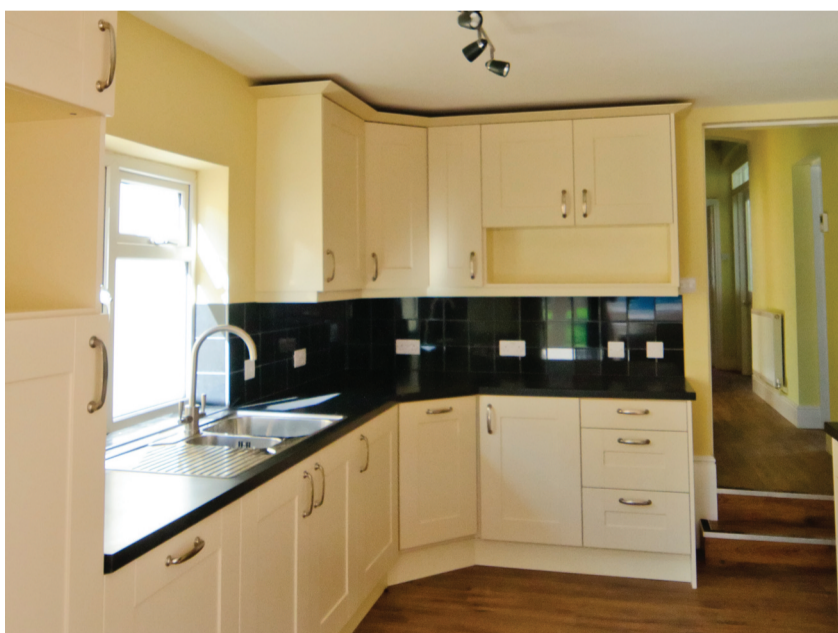
The 'Warm-Floor' is the ultimate insulation against ground damp.

1. 100mm compact stone layer, 'blinded' with sand.
2. 200-gauge membrane, cut into and sealed into the brick.
3. 100mm cellular insulation finished with 150mm concrete slab.

On top of that we lay a Karndean vinyl or carpeting.

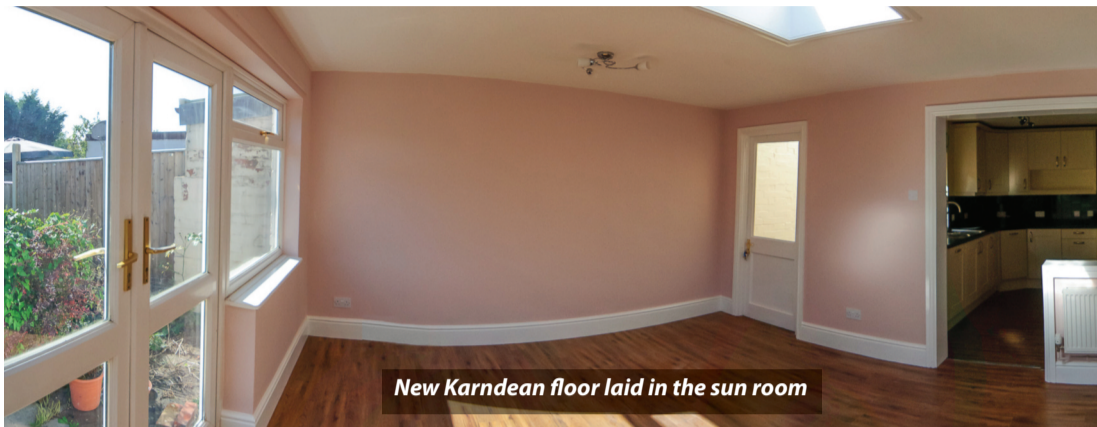
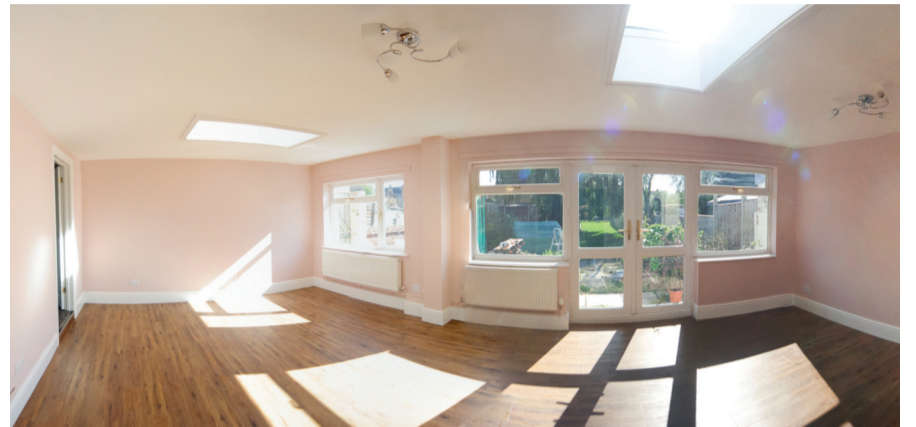
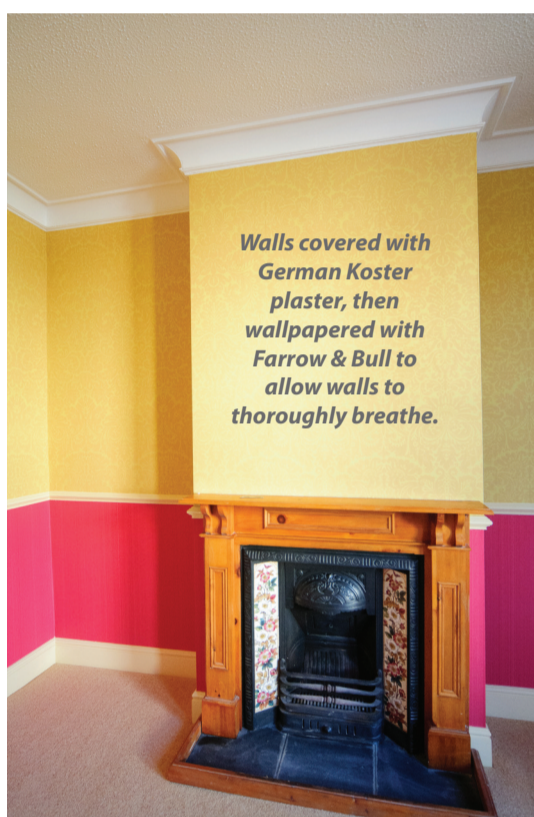
The front room

Basement filled in with compacted stone. Karndeal covering over a 'warm-floor' and radon barrier.

- Old basement filled with binding stone (solidifies after filling).
- Rebuilt floors - these were irrigated and rebuilt to the correct height. (note about 'warm floors and insulated concrete?')
- Damp dealt with by installing a silicon damp proof course. Holes drilled into brick, 2-3 courses up from the ground
- Dealt with dry rot - full irrigation treatment done. This is very labour intensive - holes have to be drilled into all the walls in a four-inch grid. Injected Biocide solution which kills any biological growth within the substrate (fabric of building)

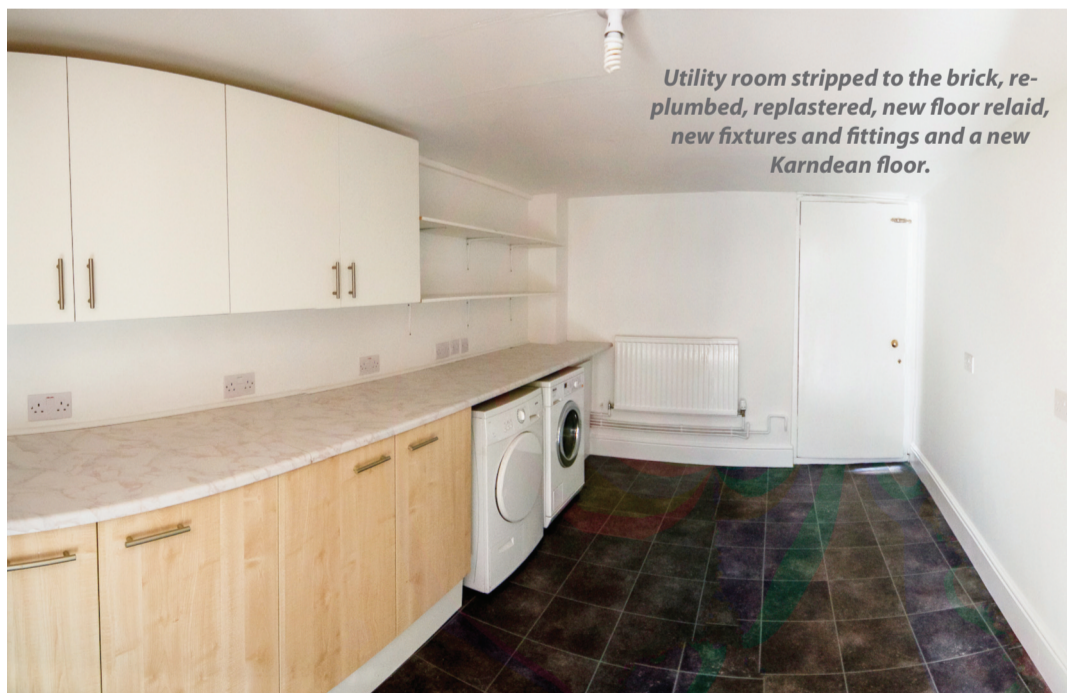
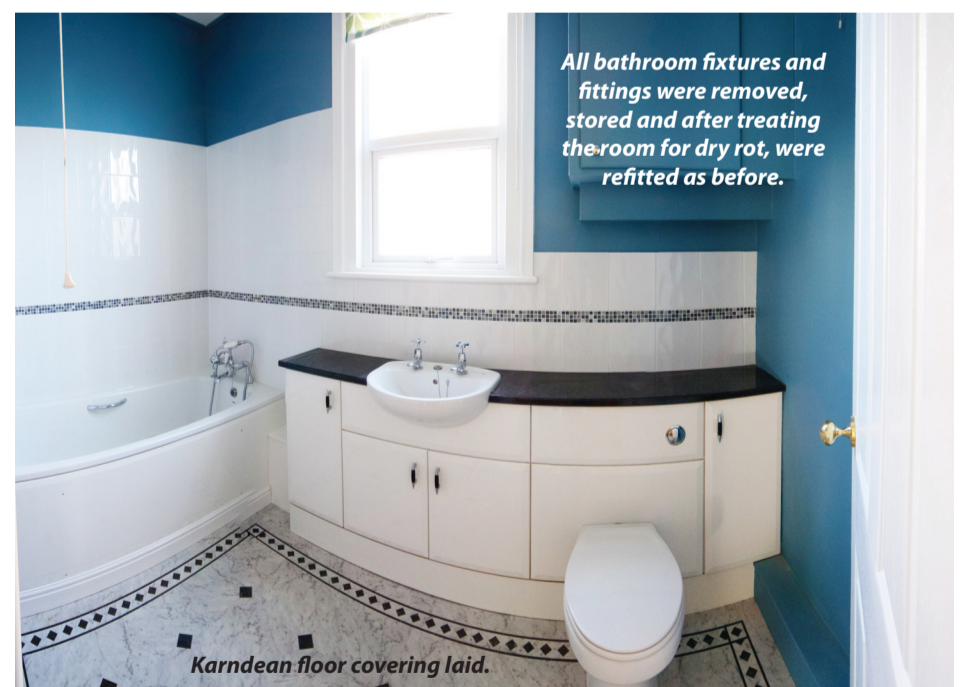
This is a high-gauge barrier which stops stops radon gas and water vapour penetrating through the concrete warm floor. Radon gas usually comes out of backfilled areas - as the backfill decomposes, gas is released. The barrier was installed here because there was backfill towards the bottom of the client's garden.
